# **Semi Truck Driver Falls Asleep While Driving, Crashes and Dies**

**Incident Number: 11KY009**

## **Kentucky Fatality Assessment and Control Evaluation (FACE) Program**

**Release Date: April 20, 2011**

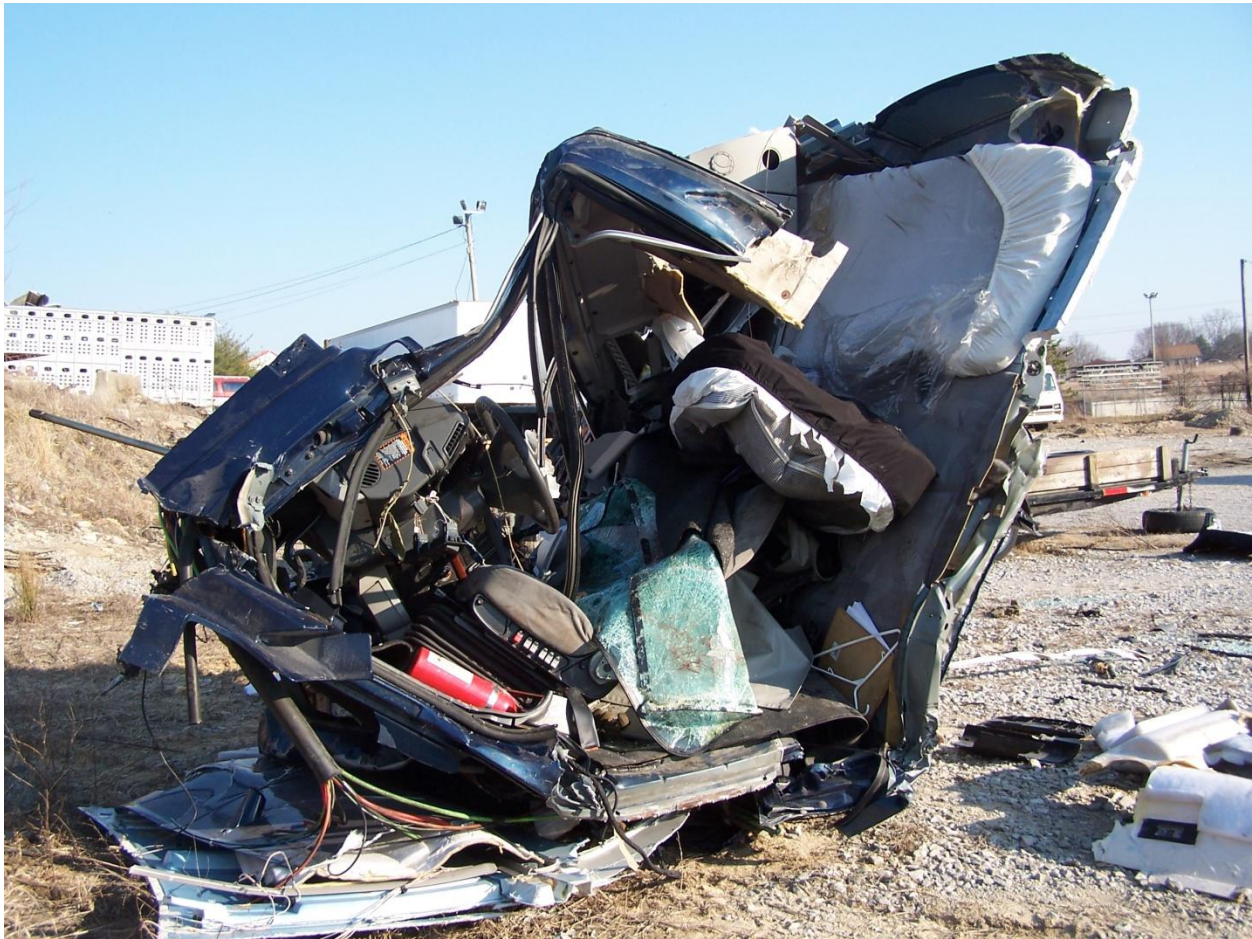
**Photograph of tractor involved in crash. Photograph property of KY FACE.**

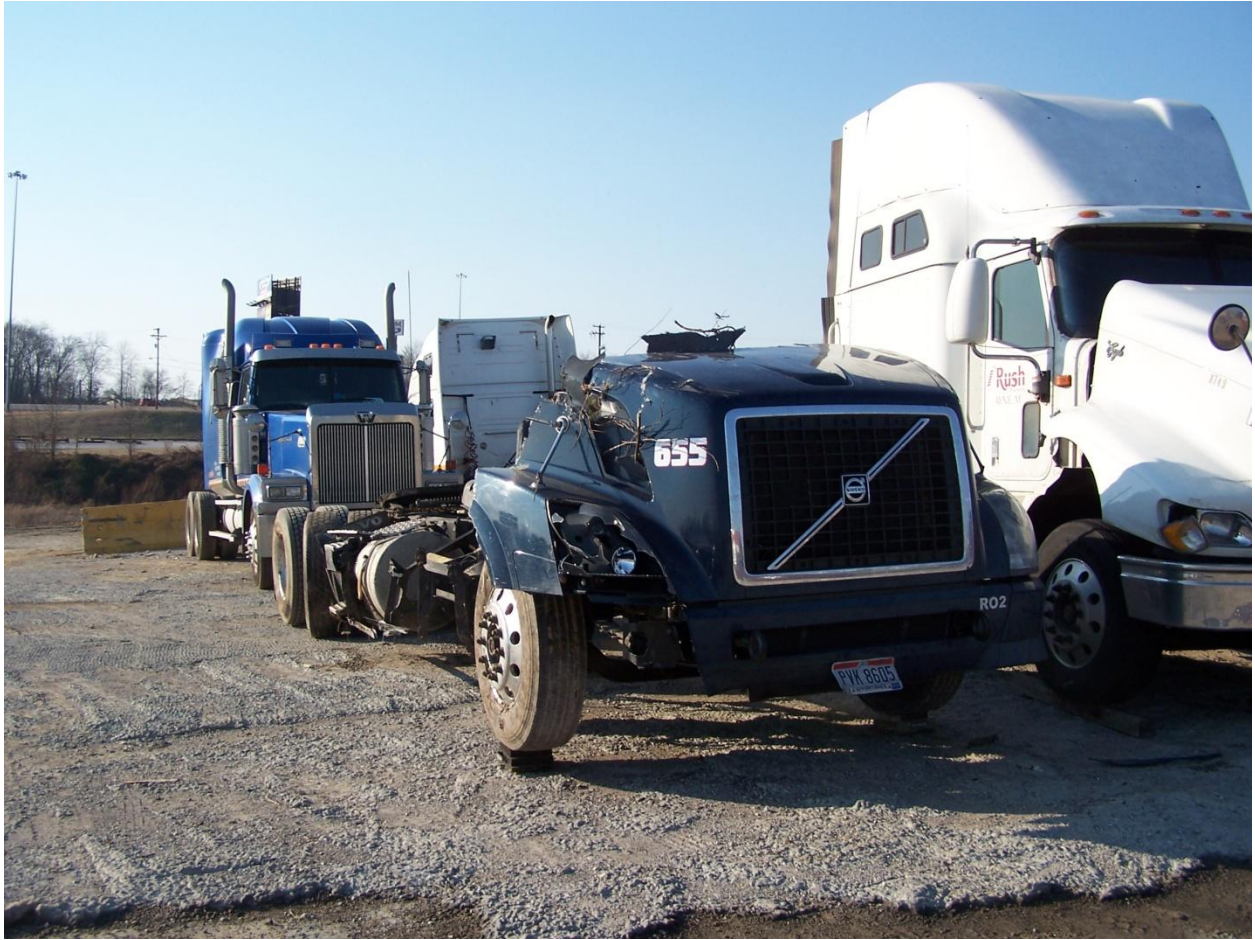
Extracting the driver from the wreckage was complicated due to the load of tomatoes that had impacted the back of the tractor from the trailer. Upon impact, the cab separated from its chassis. The driver was wearing his seatbelt and the airbag deployed upon impact. Neither speed nor alcohol were suspected as contributing factors in the crash.

Front section of semi. Photograph property of KY FACE

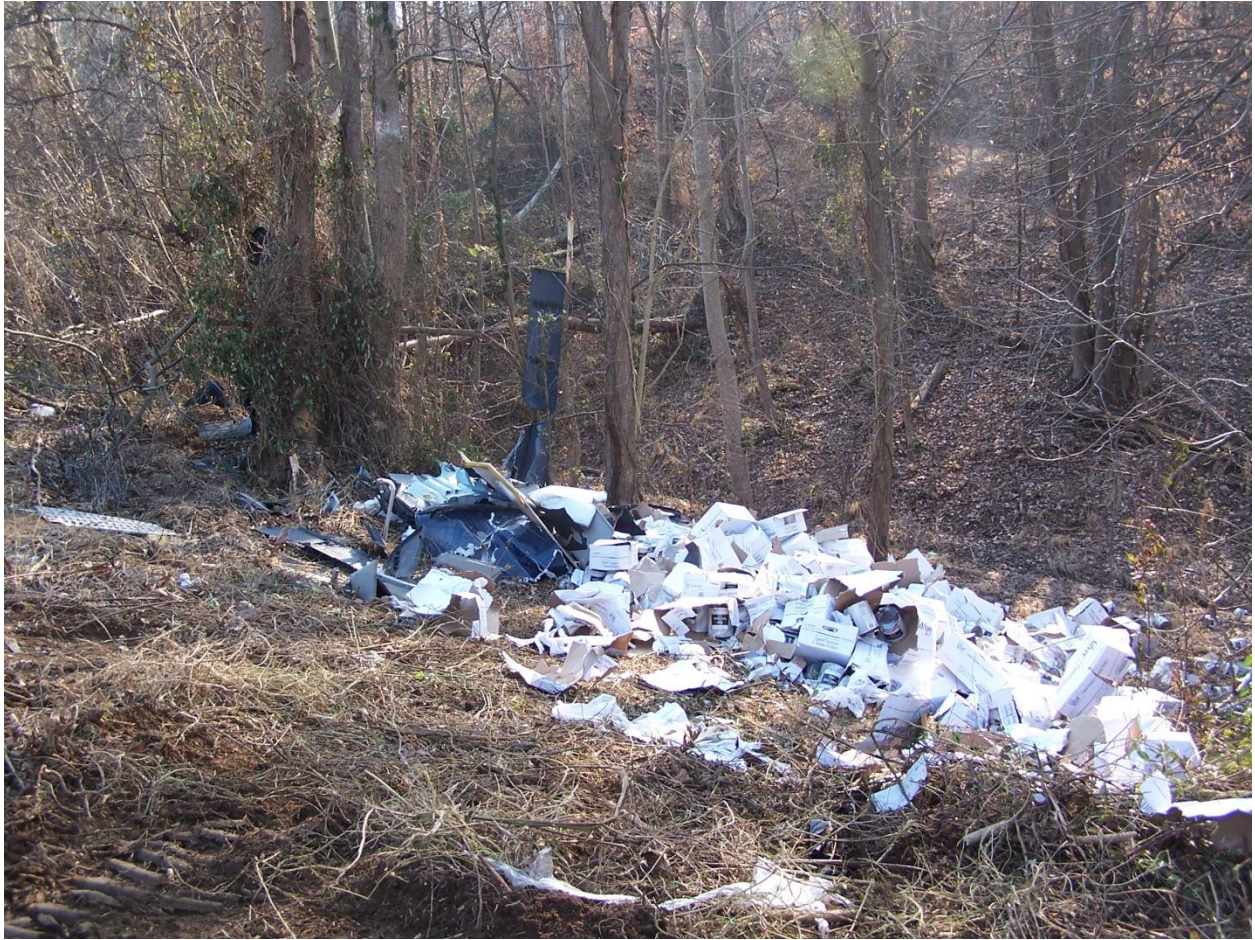
At approximately 4:15 AM, the driver was traveling in the right hand lane of a straight stretch of a four lane interstate in a 70 mph zone. The section of interstate was not lit, the pavement was asphalt and dry, and the weather clear. He had traveled approximately 380 miles from his pickup point and had 270 miles to his next destination. The driver fell asleep, drove over the rumble strip on the right side and the emergency lane, traveled behind the guardrail, rolled over onto the passenger side of the unit and slid down an embankment for 310 feet into a stand of trees. The impact of the tractor striking the trees caused the load of tomatoes to shift forward in the trailer and exit the trailer into the tractor.

Load of canned tomatoes ejected from semi. Photograph property of KY FACE.

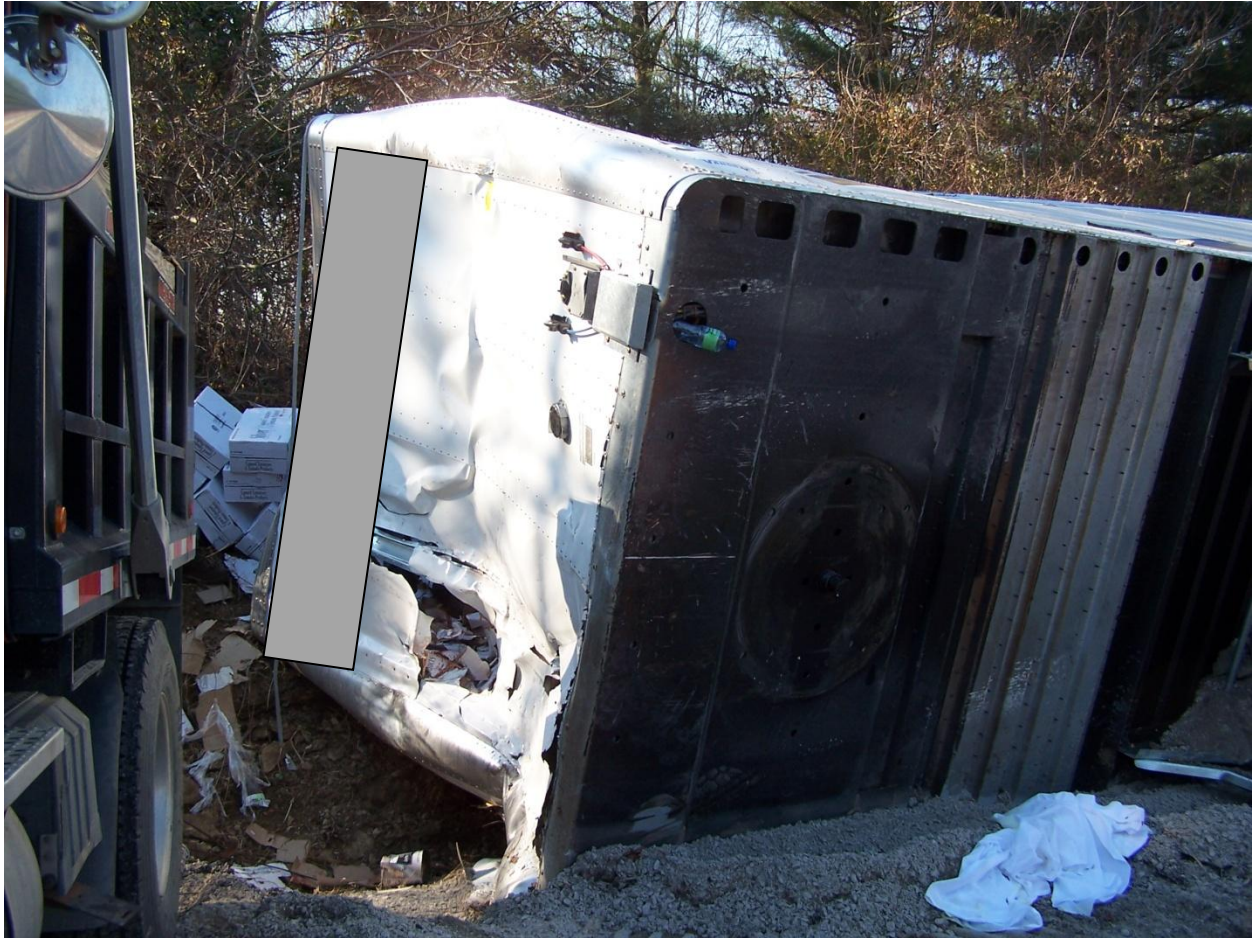
Trailer involved in crash. Load was ejected out of the top and into the cab. Photograph property of KY FACE.
